# Product Data

## Industrial Coating for Corrosion Protection at Elevated Temperatures

Belzona® 1591 (Ceramic XHT) is a two component high temperature coating system designed to resist water, hydrocarbons, aqueous solutions and pressurised steam up to a temperature of 180°C (356°F).

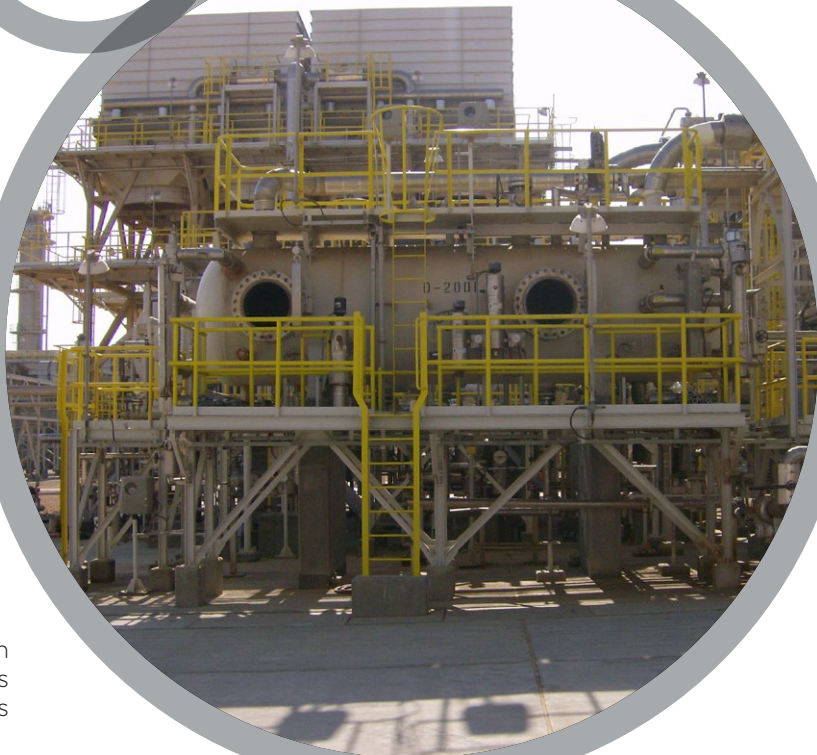
Separators
