Product Data

Heat Activated Repair Compound for Application to, and Repair of, Hot Surfaces

Belzona® 1251

HA-Metal

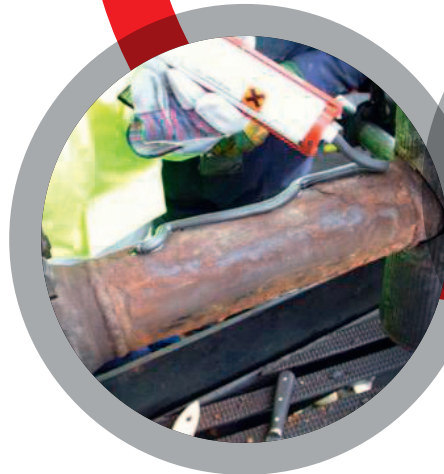
Bonding Doubler Plates

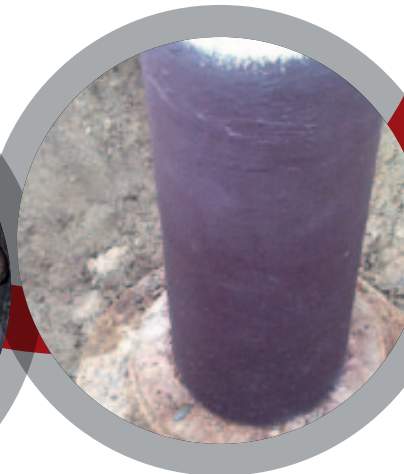
Repair of Thin Wall Defects

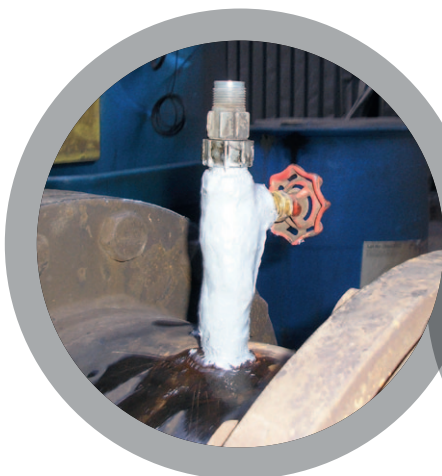
Leak Sealing of Pipework

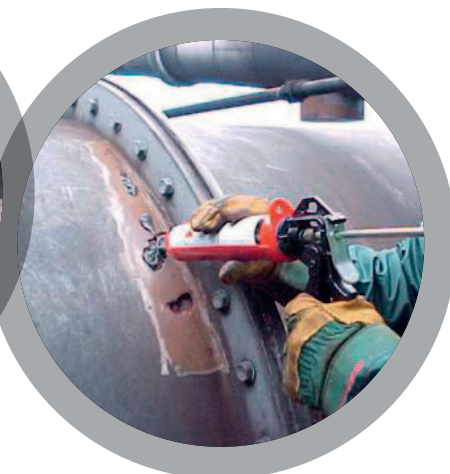
Infill of Corrosion Pits

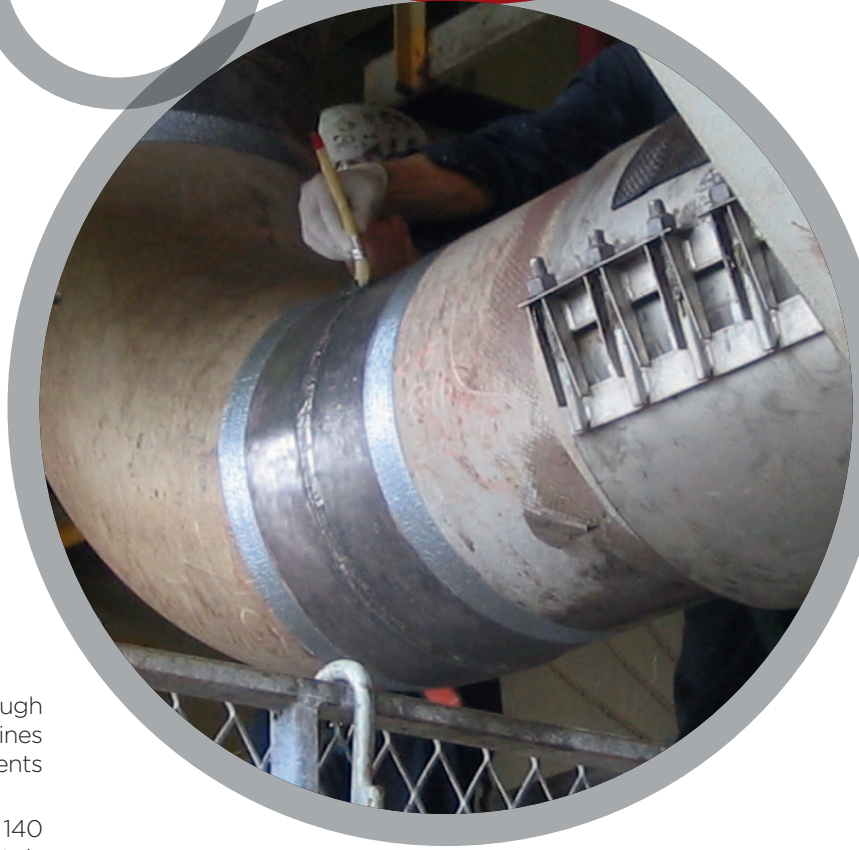
Local Repairs
